Cobham SATCOM
Lundtoftegaardsvej 93 D
2800 Kgs. Lyngby
Denmark

Document Number: 95-154868-A

SAILOR VSAT **SW ver. 1.57 Build 021**

Please be informed that new software, version 1.57 build 021 for SAILOR 60 GX – SAILOR 100 GX, has been released.

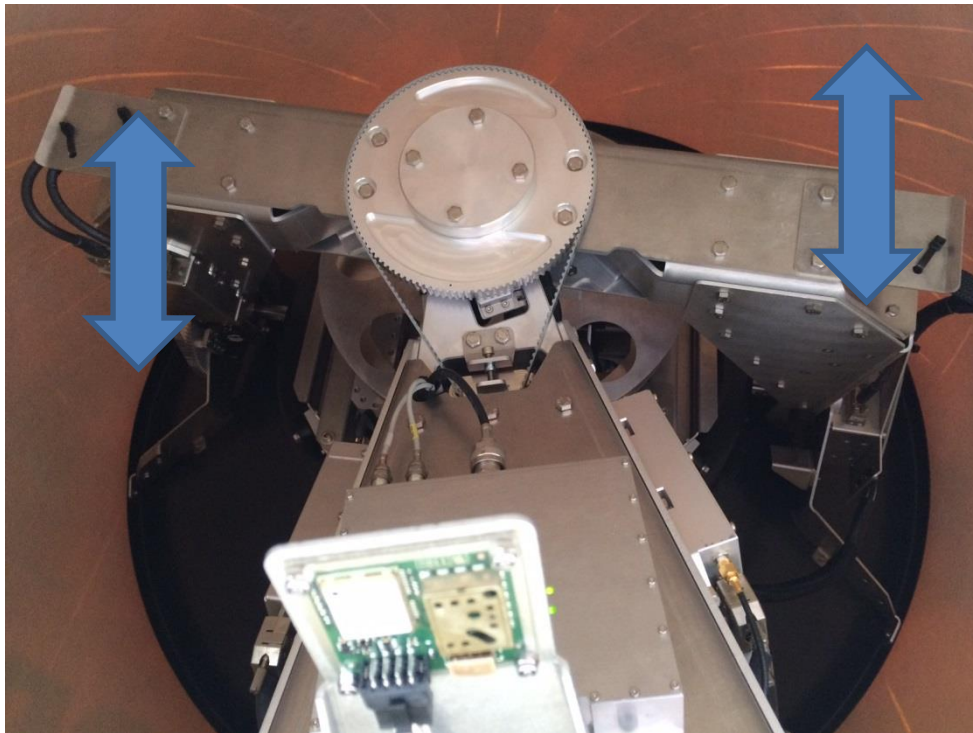
Appendix I.

Cross-Elevation Bearing performance optimization.

To achieve a good grease distribution in the X-elevation bearing, on vessels with a minimum of motions, the X-elevation bar is now moved $\pm 20^\circ$ within a period of 8 hours. (0 \rightarrow $+20^\circ$ \rightarrow 0 \rightarrow -20° \rightarrow 0, in a linear pattern)

That will help minimizing the friction in the bearing.

If the vessel motions increases (**roll** $> 10^\circ$) this function is stopped and the X-elevation bar is moved back to horizontal.
